ANGKOR VAT

INDIA'S CONTRIBUTION IN CONSERVATION

MEMOIRS OF THE
ARCHAEOLOGICAL SURVEY OF INDIA
NO. 91

B. NARASIMHAIAH

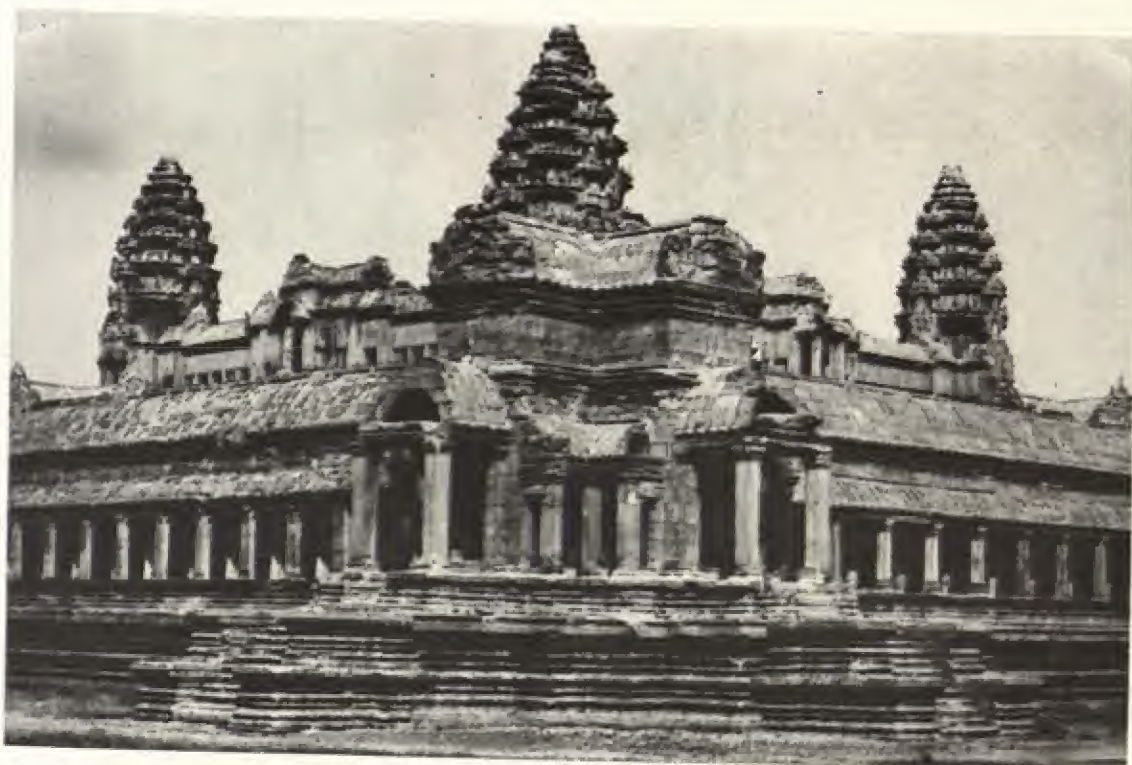
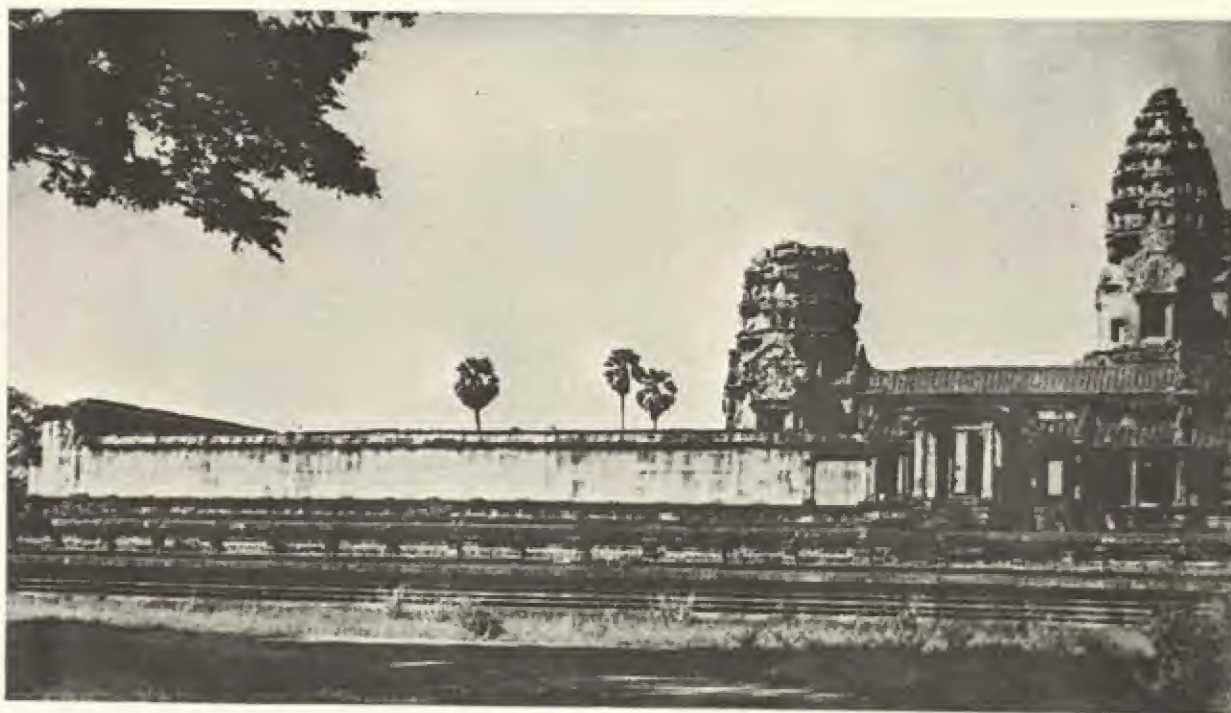
*Third Enclosure : south-eastern corner entrance pavilion with porches, A, before
and B, after conservation*

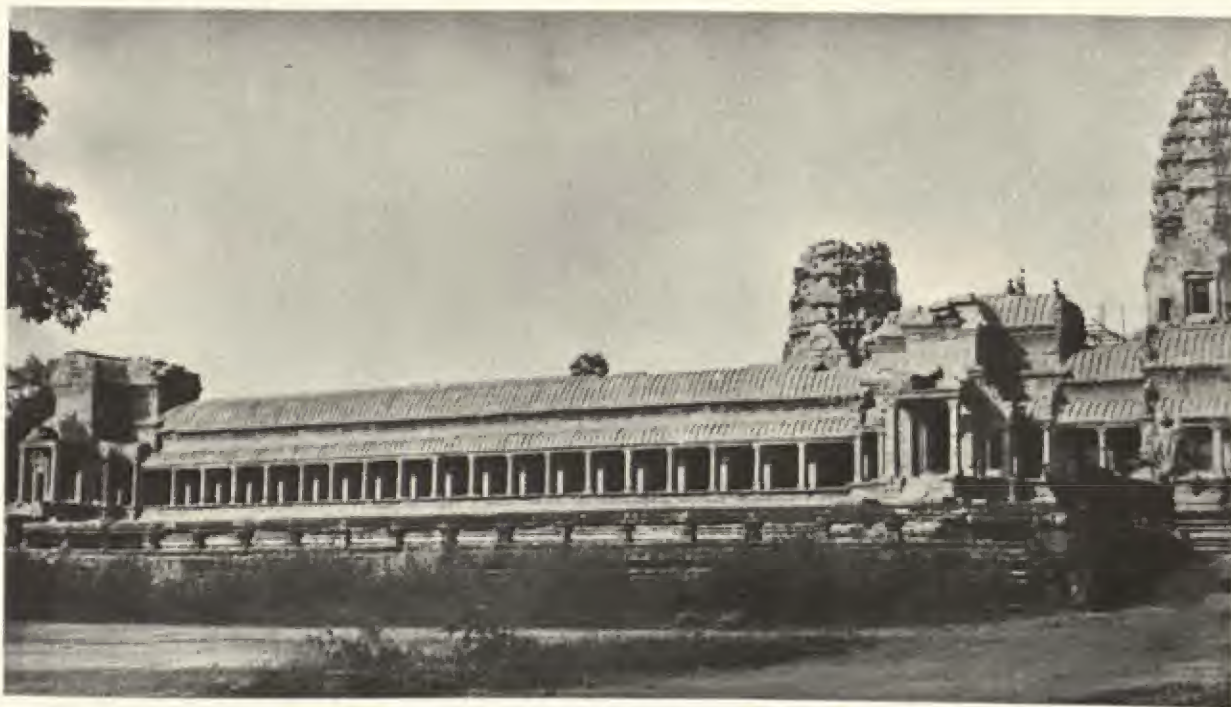
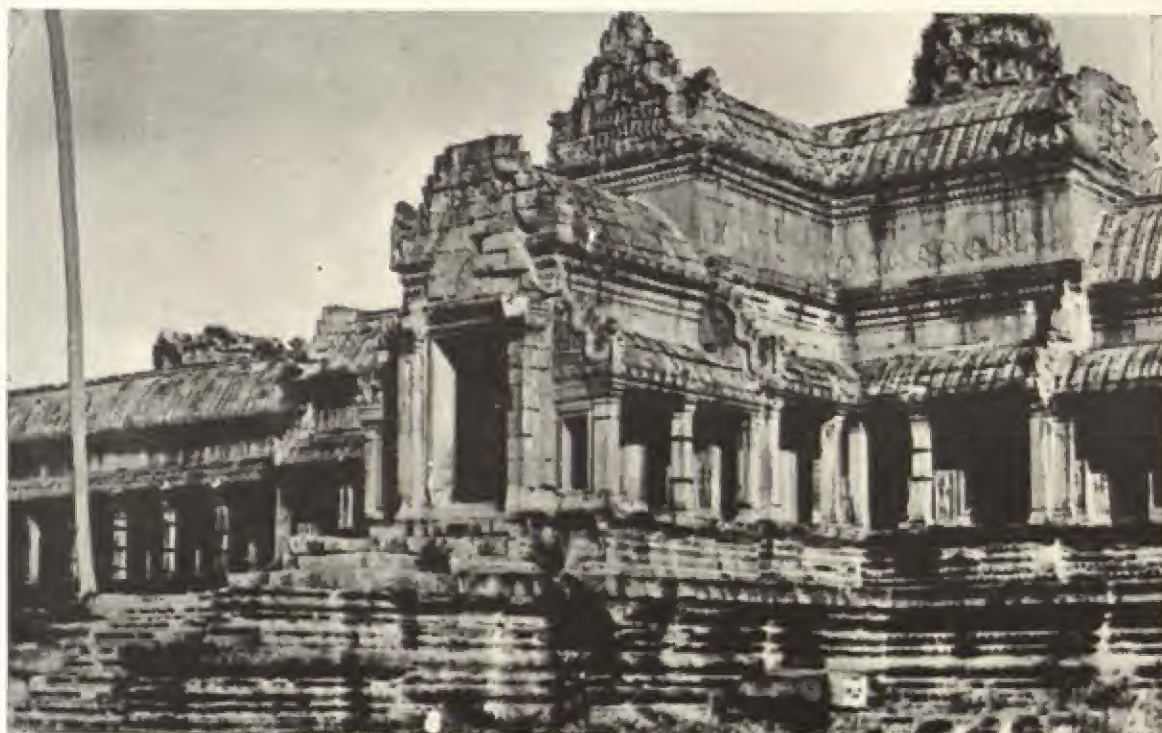
Third Enclosure : Samudramanthana Gallery and flanking entrance pavilions, A, before and B, after conservation

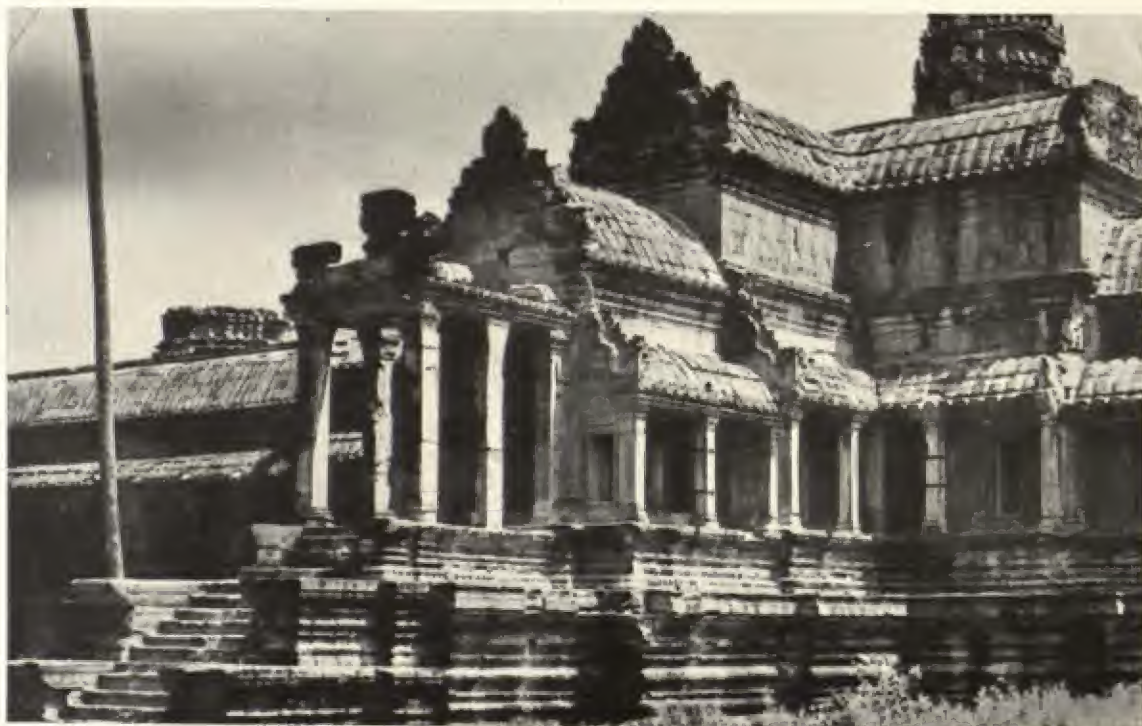
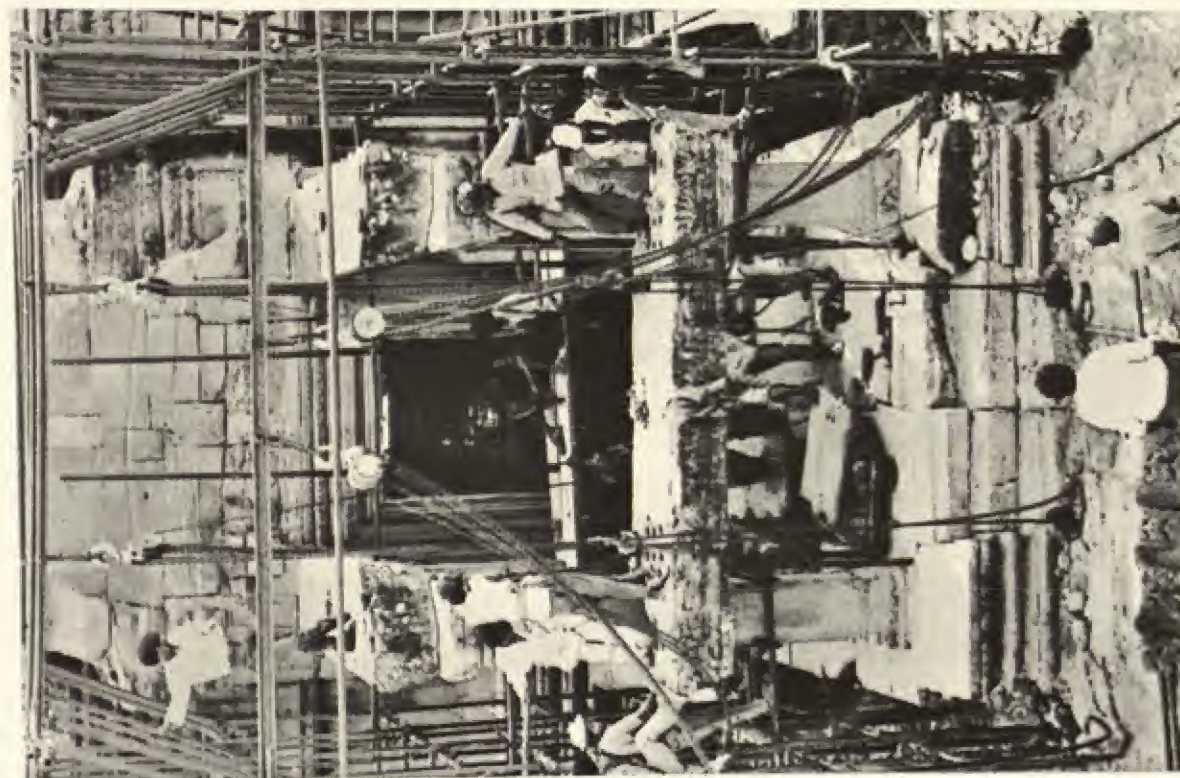
Third Enclosure : southern-central entrance porch, A, before and B, after conservation

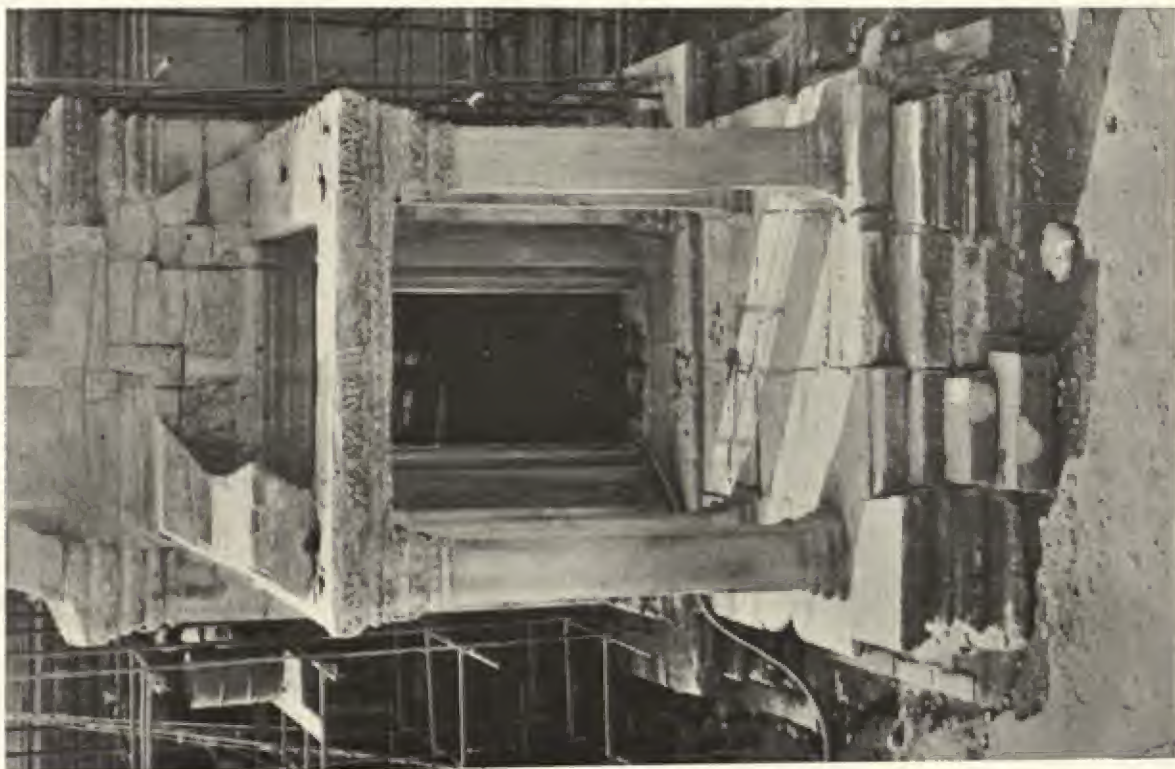
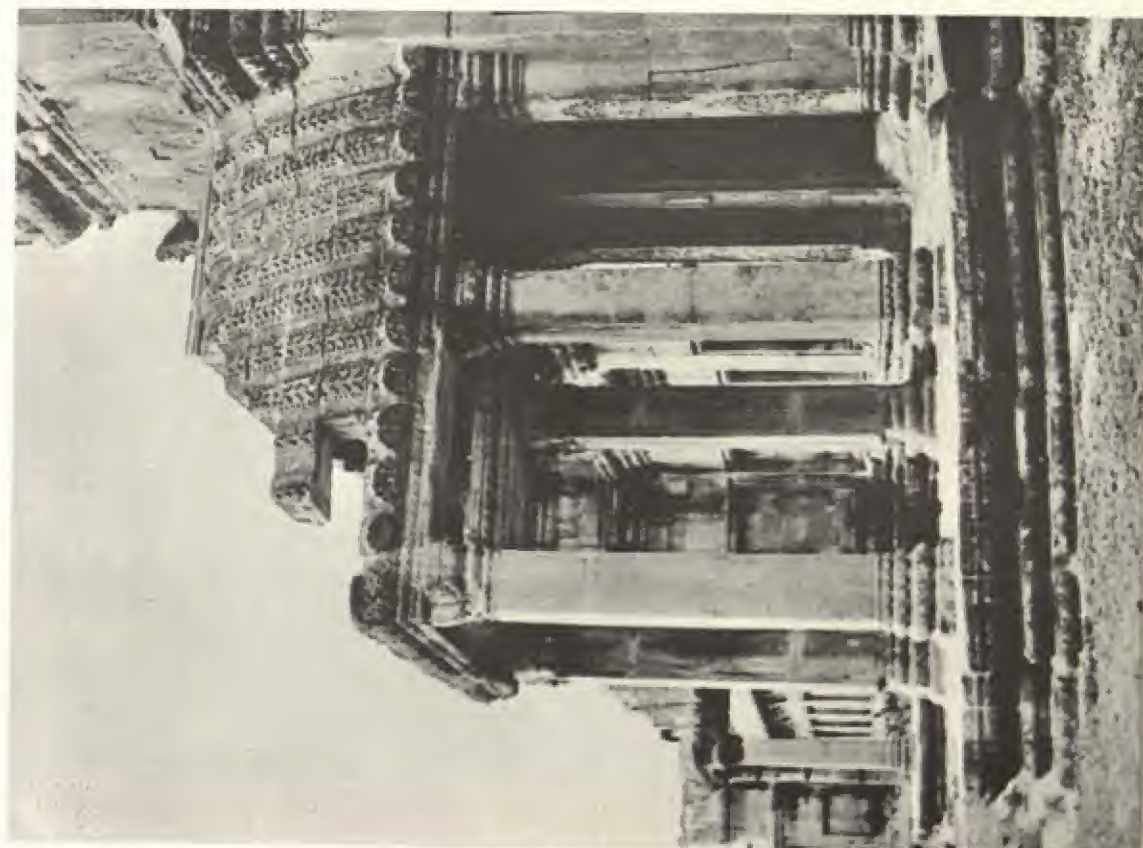
Third Enclosure : inner entrance porch on southern side, A, during and B, after conservation

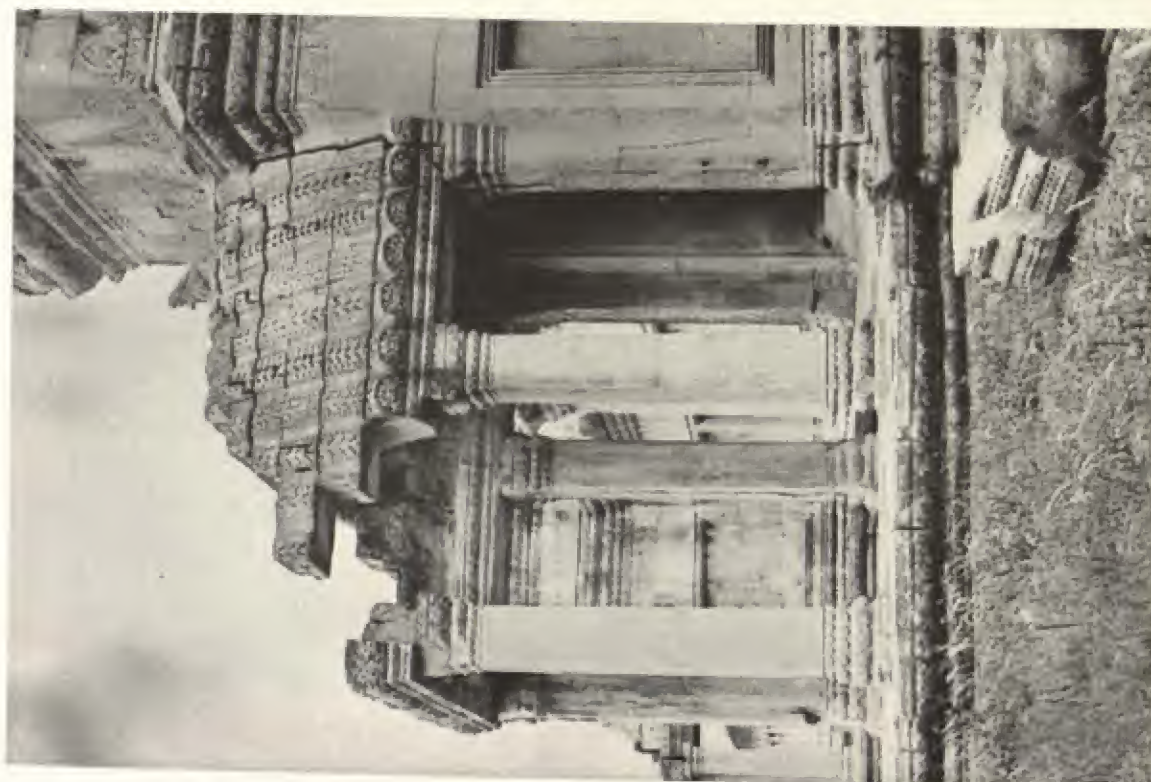
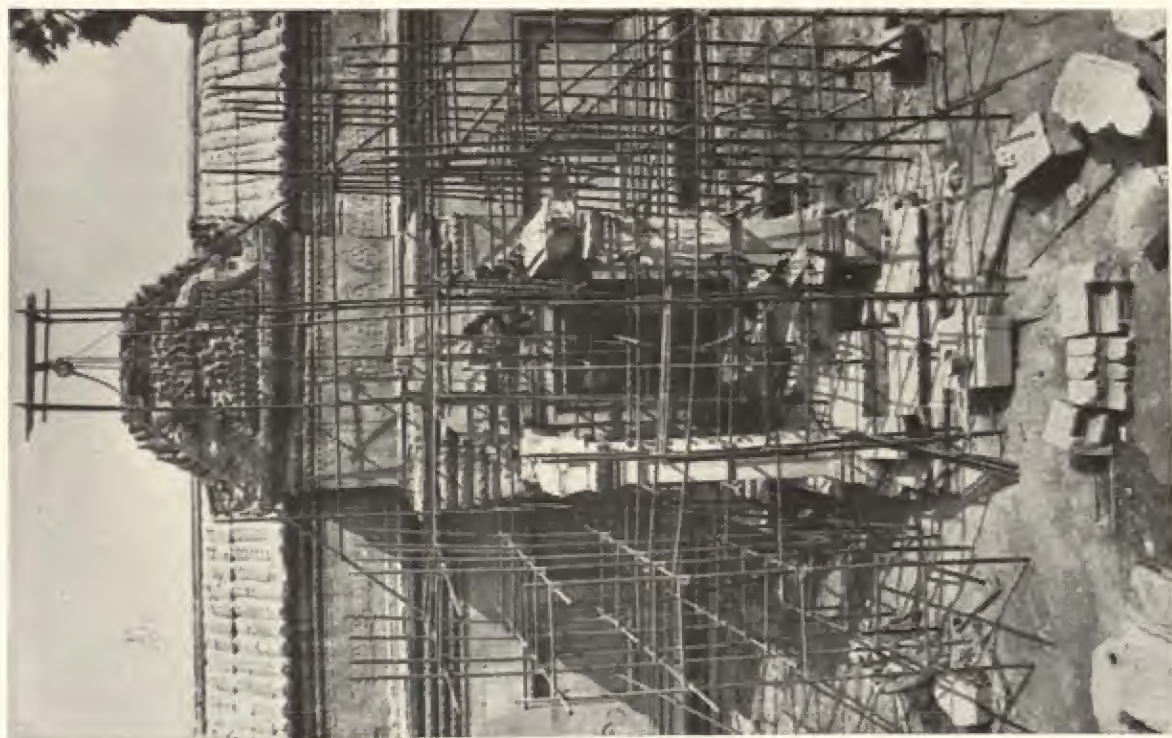
Third Enclosure : central inner entrance porch on eastern side, A, before and B, after conservation

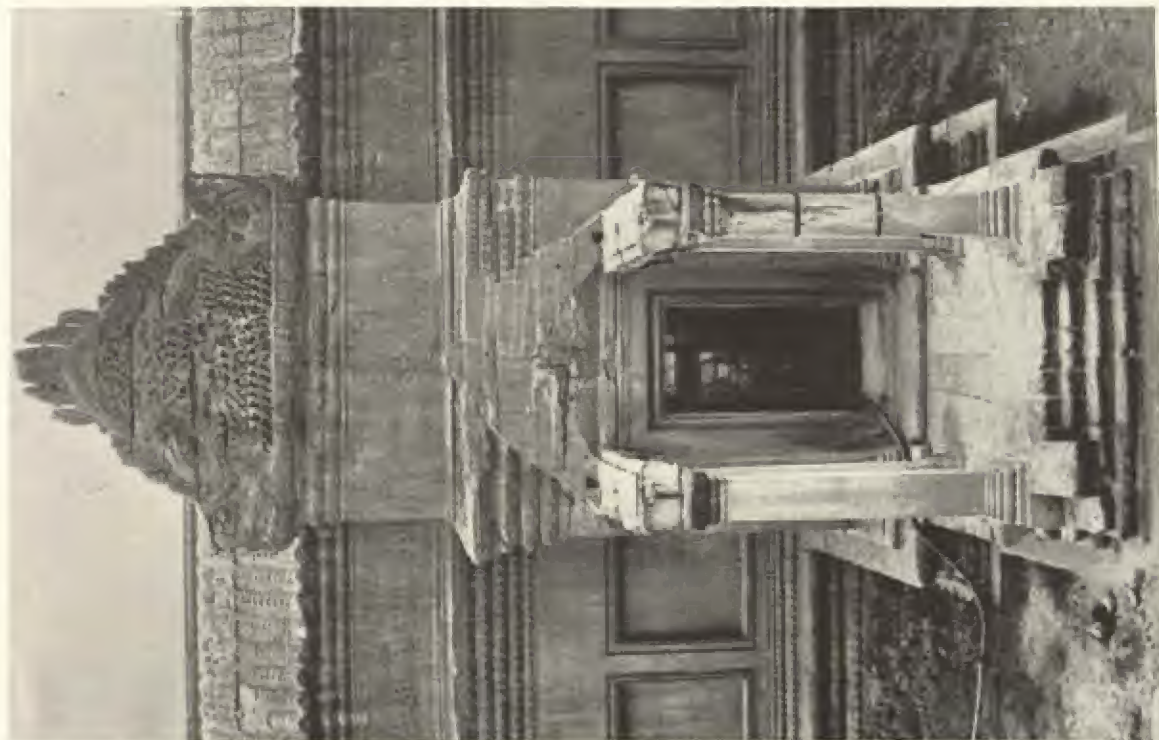
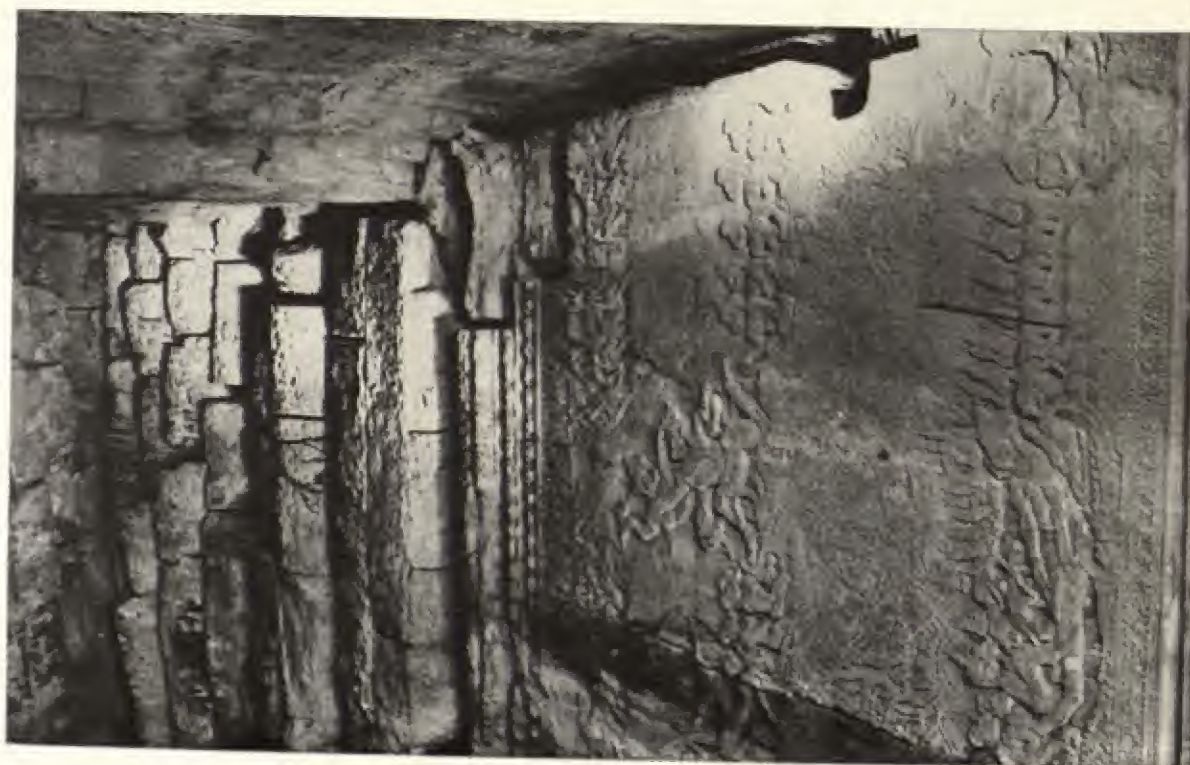
Third Enclosure : inner entrance porch on northern side. A, during and B, after conservation

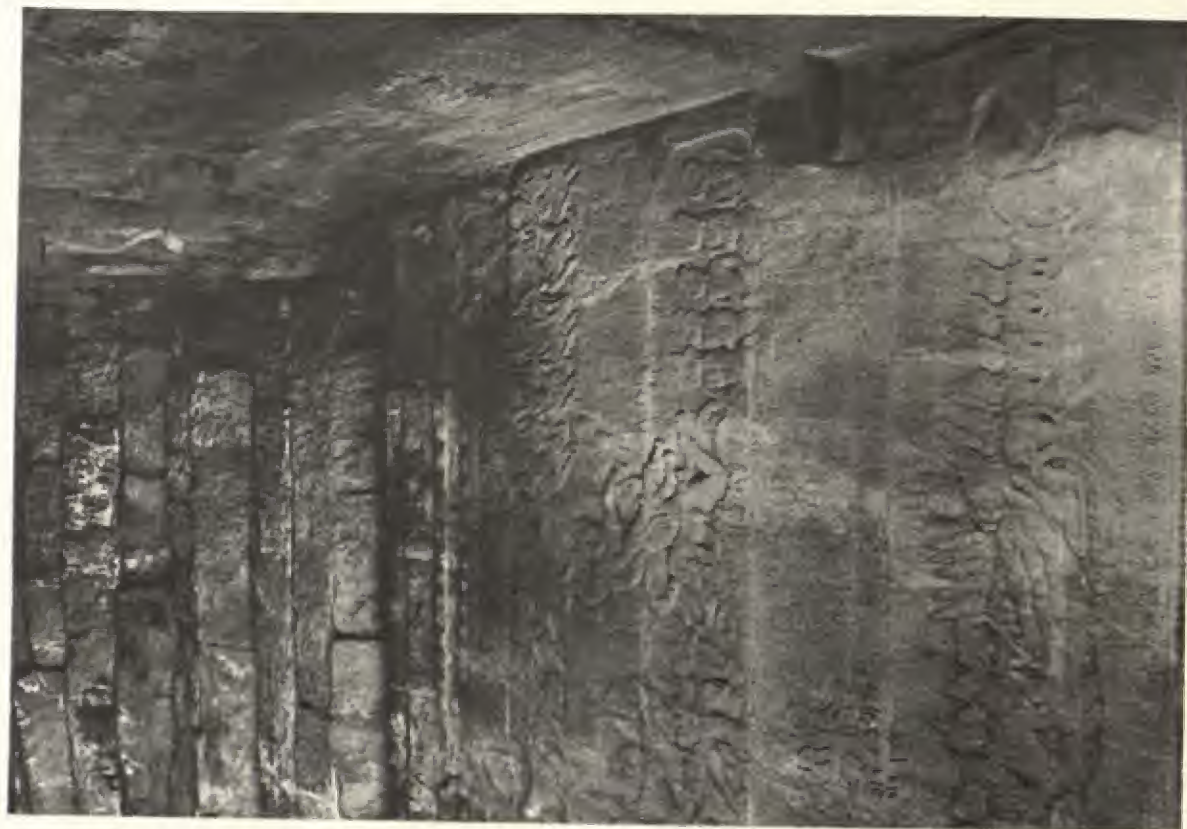
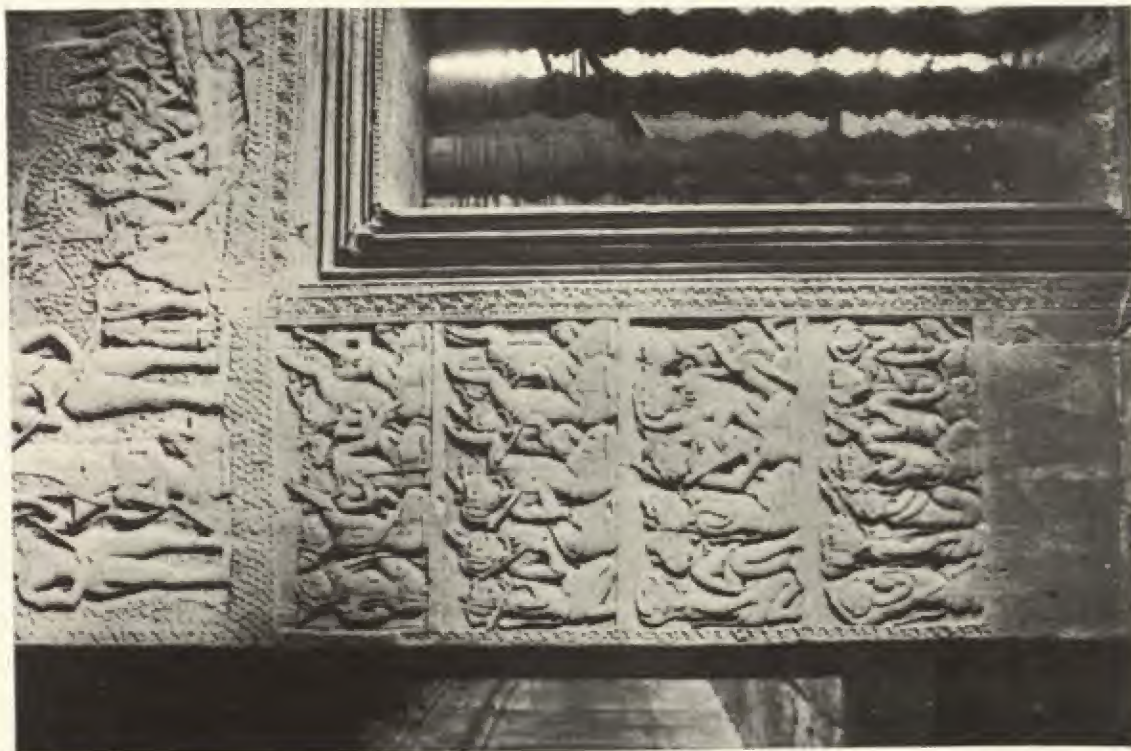
Third Enclosure : south-western corner entrance pavilion, A, before and B, after conservation

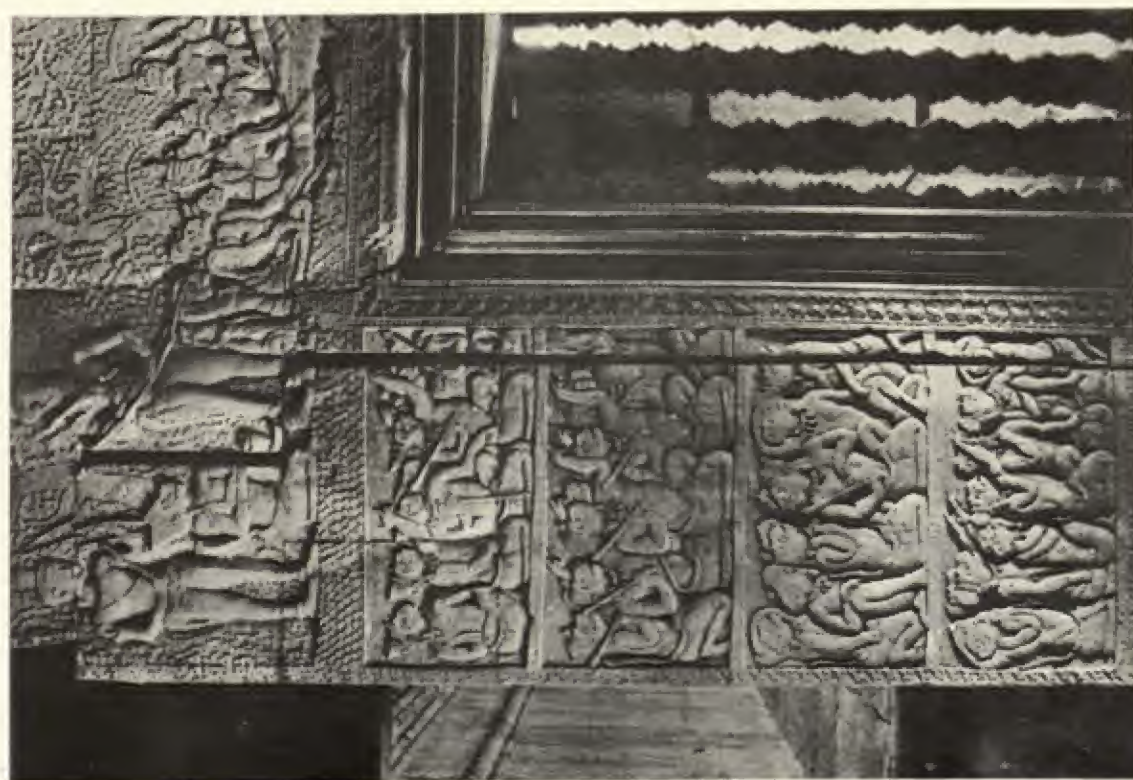
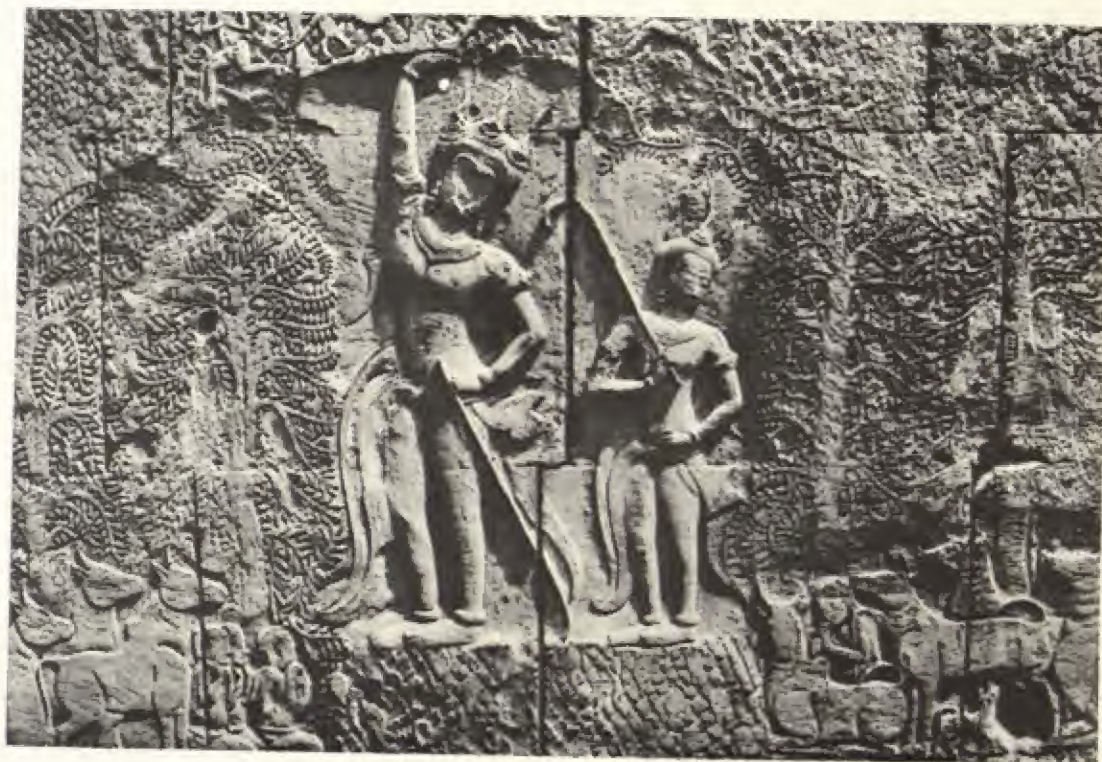
Third Enclosure : south-western corner entrance pavilion, A, before and B, after conservation

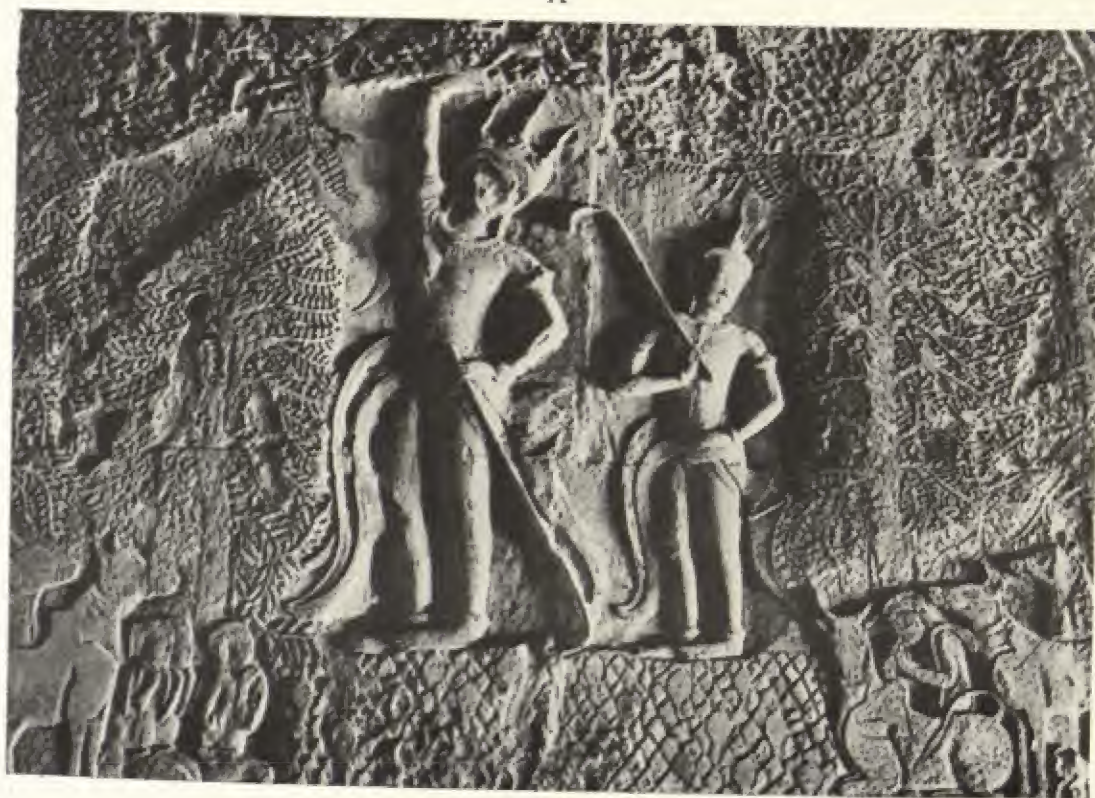
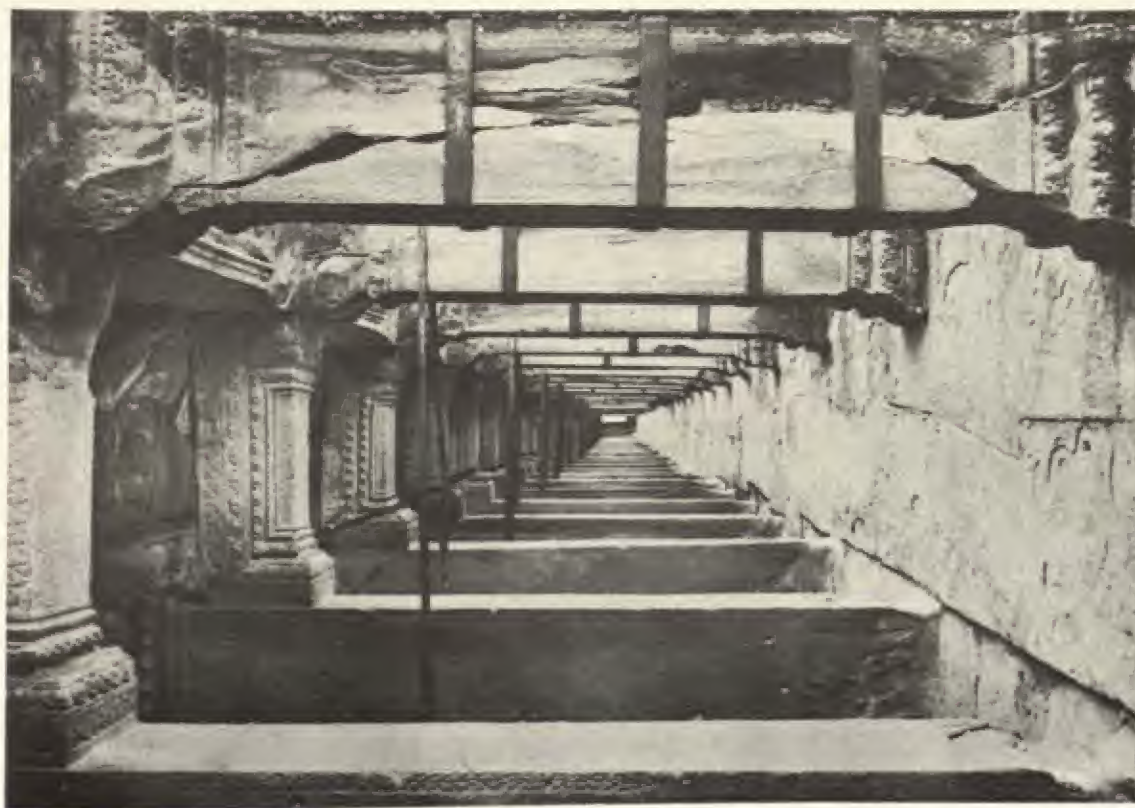
Third Enclosure : south-western corner entrance pavilion, A, before and B, after conservation

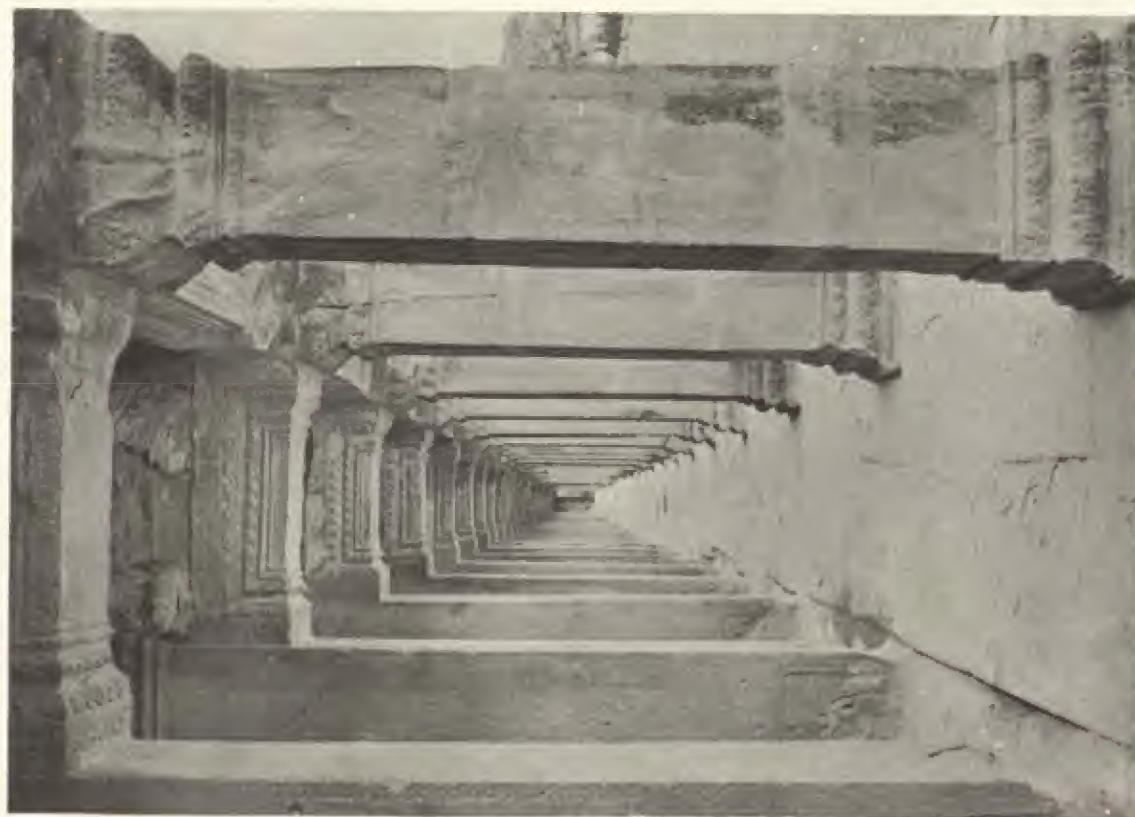
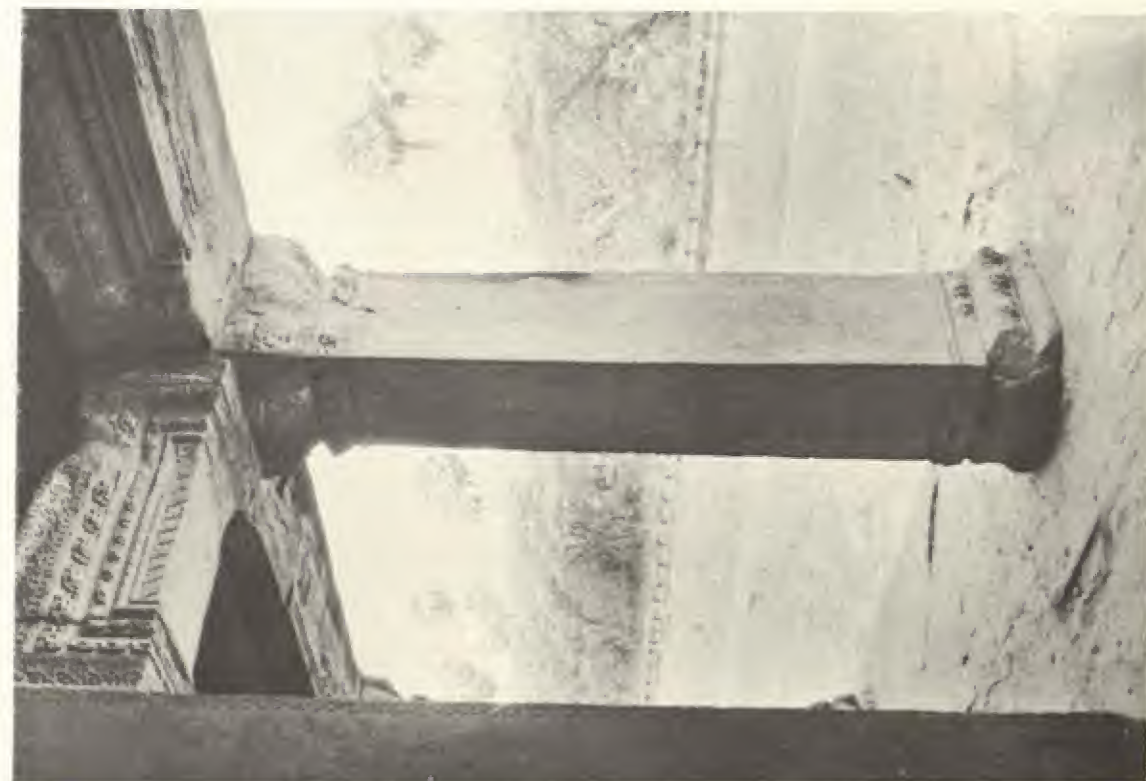
Third Enclosure : Western Gallery, A, before and B, after conservation

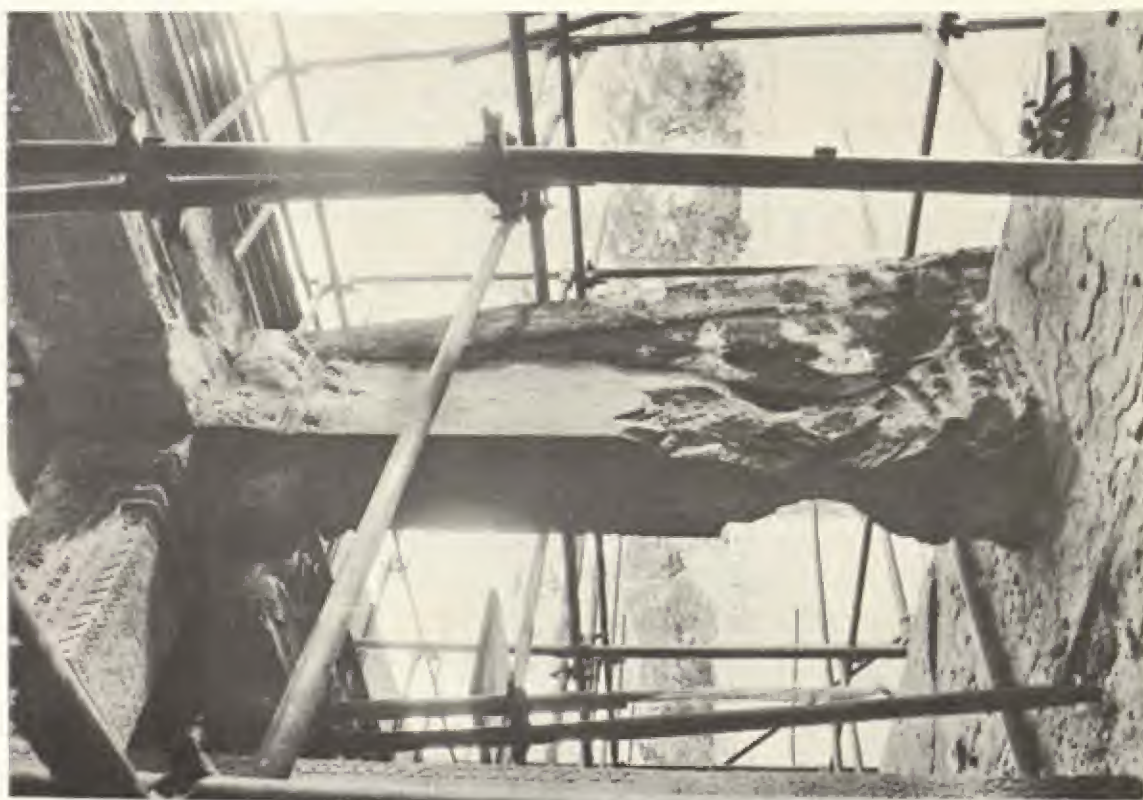
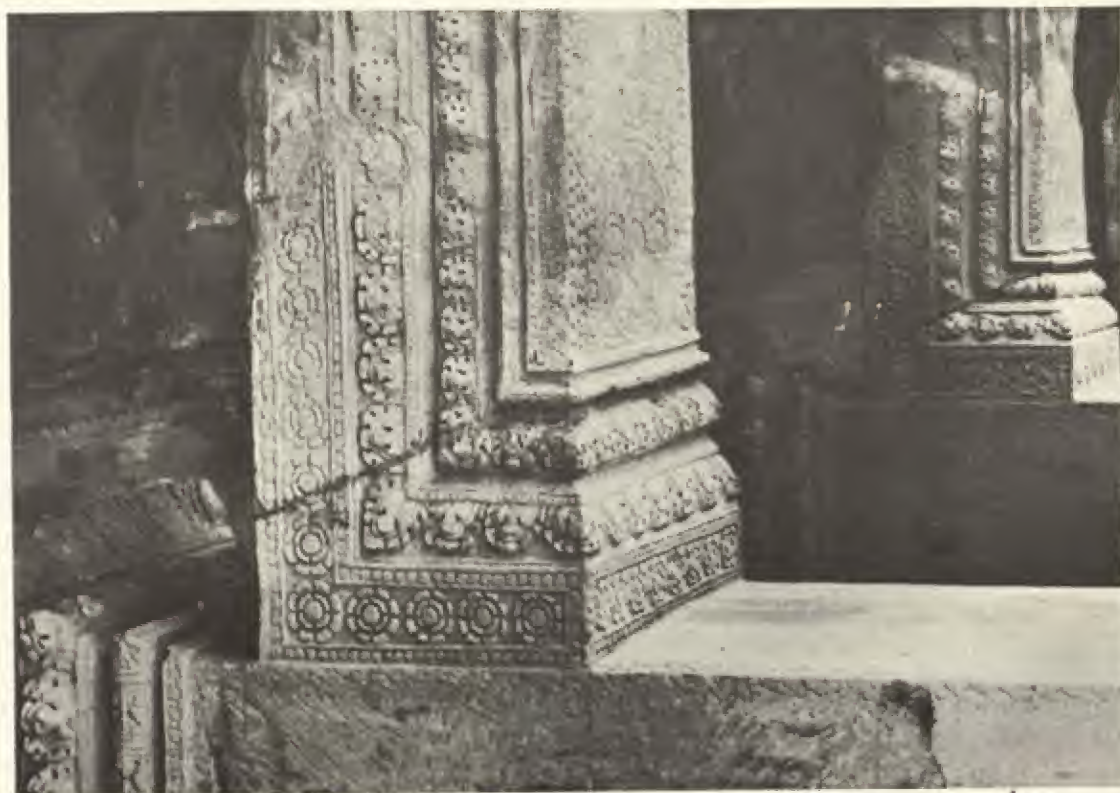
Third Enclosure : Western Gallery, A, before and B, after conservation

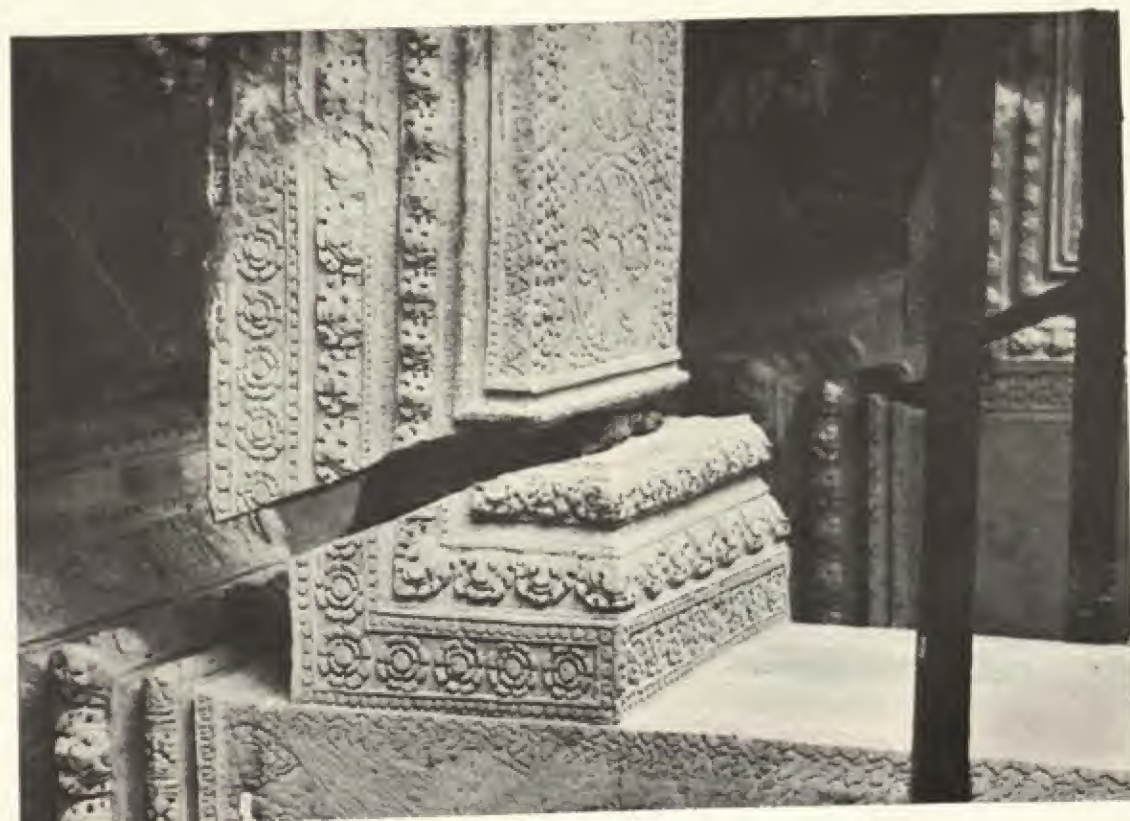
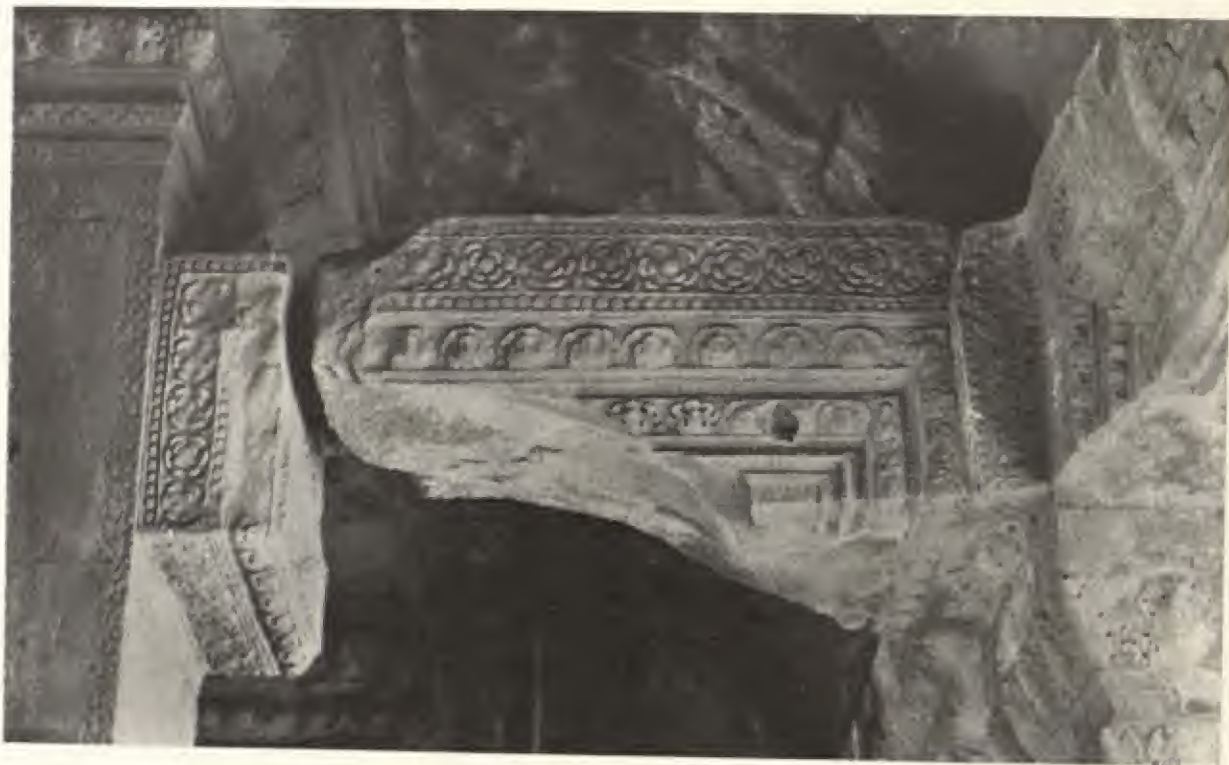
Third Enclosure : Western Gallery. A, before and B, after conservation
